**Flood Control Project Maintenance
Levee Inspections**

Fall 2010 Levee Maintenance Deficiency Summary Report

Sacramento River Basin

Reclamation District No. 0900 West Sacramento

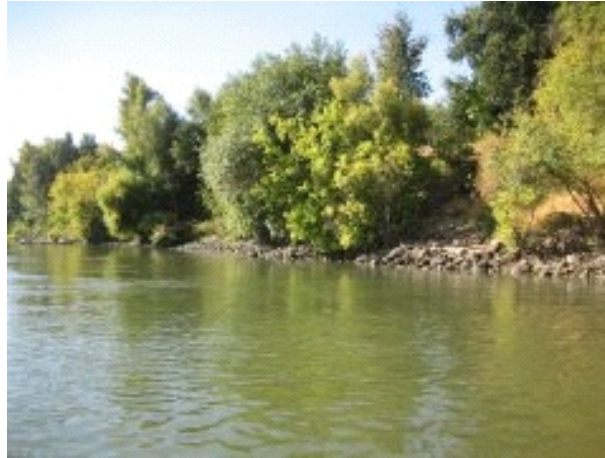
Levee Mile Report Line	1
Start Levee Mile	1.92
End Levee Mile	2.03
Location	Water Side
Category	Supplemental
Item	USACE Erosion Survey
2009: no berm, 1.5:1 slope, tree hazards, holes, and slumping, sands and silts, 5.16 ft/s plus eddy currents [2009 SiteID:SAC_57-2_R]	
dpesaven_f_20100928_383.JPG

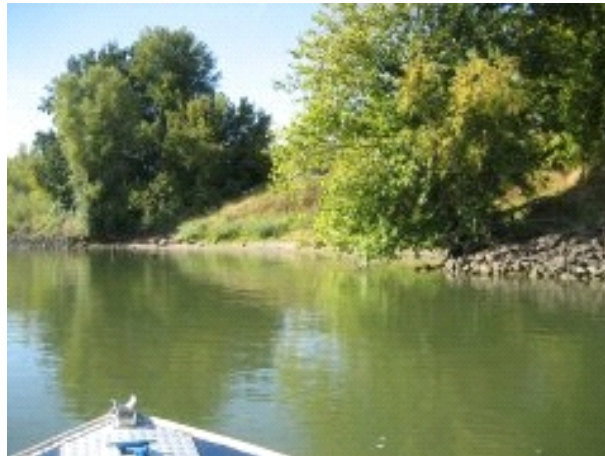
Levee Mile Report Line	4
Start Levee Mile	2.08
End Levee Mile	2.12
Location	Water Side
Category	Supplemental
Item	USACE Erosion Survey
2009: no berm, 2:1 slope, tree hazards and seepage, sands and silts, 5.02 ft/s plus eddy currents [2009 SiteID:SAC_57-0_R]	
dpesaven_f_20100928_384.JPG

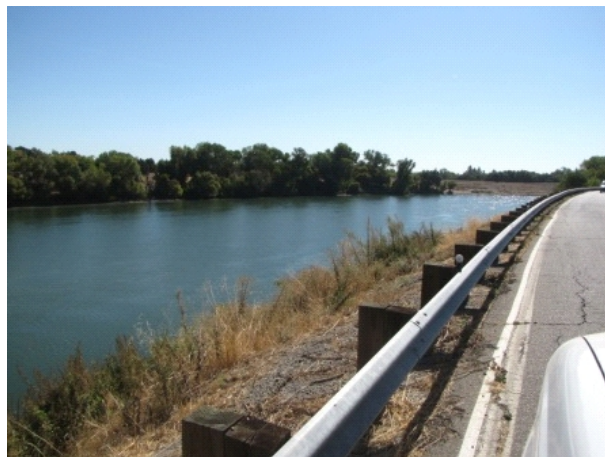
Levee Mile Report Line	25
Start Levee Mile	2.90
End Levee Mile	2.90
Location	Water Side
Category	Earthen Levee
Item	Vegetation
View of vegetation within the top 20' of the waterward slope looking downstream.	
dpesaven_f_20101012_470.jpg

25	2.90	2.90	Earthen Levee	Vegetation	WS	M	Remove the wild growth other than native grasses from the levee slopes.	38.546783 ° -121.512878 °	38.546783 ° -121.512878 °	11 Y
26	3.33	3.33	Earthen Levee	Encroachments	LS	PO	Poles	38.540802 ° -121.514249 °	38.540802 ° -121.514249 °	41
27	3.34	3.46	Supplemental	USACE Erosion Survey	WS	U	Inspector Comments: 2009: no berm, 1:1 slope, tree hazards, holes, slumping, and seepage, sands and silts, 4.46 ft/s [2009 SiteID:SAC_55-7_R]	38.540333 ° -121.513889 °	38.538969 ° -121.515456 °	31 Y
28	3.37	3.37	Earthen Levee	Encroachments	LS	PO	Poles	38.540366 ° -121.514652 °	38.540366 ° -121.514652 °	42
29	3.41	3.41	Earthen Levee	Encroachments	LS	PO	Poles	38.539922 ° -121.515014 °	38.539922 ° -121.515014 °	43
30	3.43	3.43	Earthen Levee	Encroachments	LS	PO	Poles	38.539712 ° -121.515402 °	38.539712 ° -121.515402 °	44
31	3.44	3.44	Earthen Levee	Trim / Thin Trees	WS	C	Thin trees to allow visibility of the ground and room to flood fight.	38.539597 ° -121.515447 °	38.539597 ° -121.515447 °	970

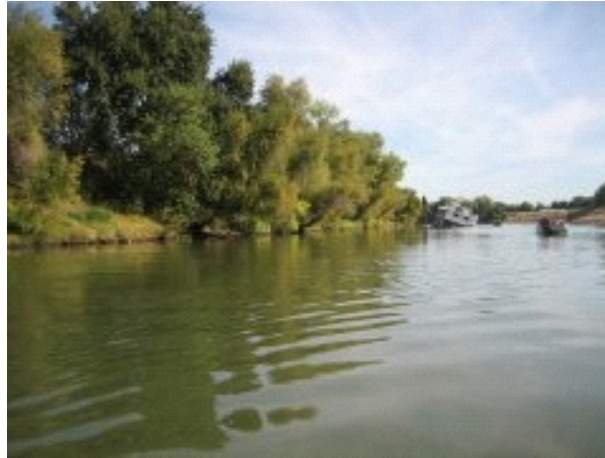
Levee Mile Report Line	27
Start Levee Mile	3.34
End Levee Mile	3.46
Location	Water Side
Category	Supplemental
Item	USACE Erosion Survey

2009: no berm, 1:1 slope, tree hazards, holes, slumping, and seepage, sands and silts, 4.46 ft/s [2009 SiteID:SAC_55-7_R]

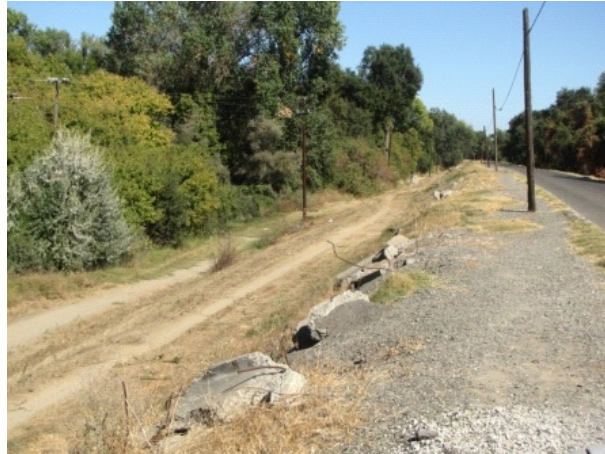
Levee Mile Report Line	49
Start Levee Mile	4.11
End Levee Mile	4.11
Location	Land Side
Category	Earthen Levee
Item	Encroachments

View of concrete debris with metal looking upstream.

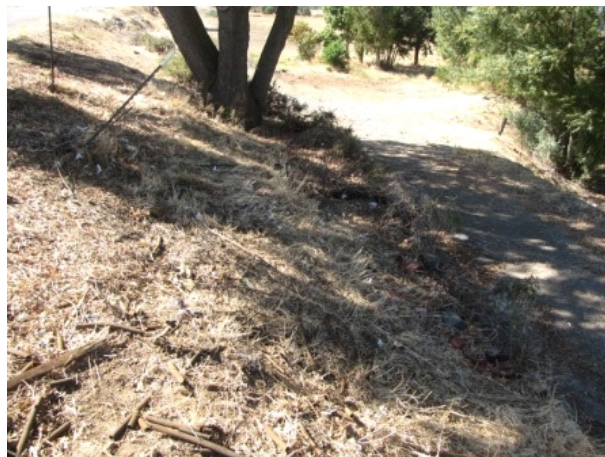
Levee Mile Report Line	61
Start Levee Mile	5.59
End Levee Mile	5.59
Location	Land Side
Category	Earthen Levee
Item	Encroachments

View of a retaining wall and vegetation along the edge of the ramp looking downstream.

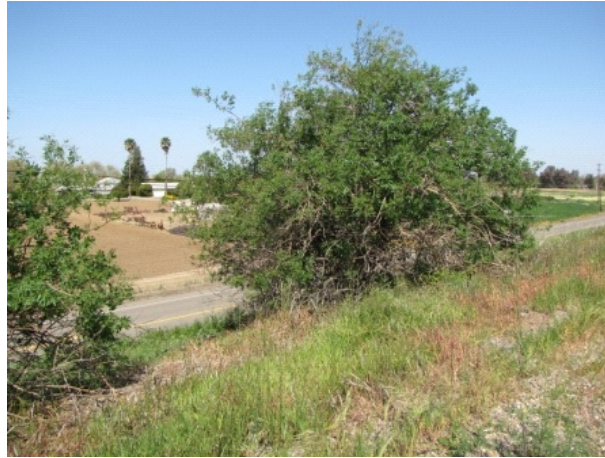
Levee Mile Report Line	70
Start Levee Mile	7.27
End Levee Mile	7.27
Location	Land Side
Category	Earthen Levee
Item	Vegetation

View of elderberries blocking visibility on the landward slope looking upstream.

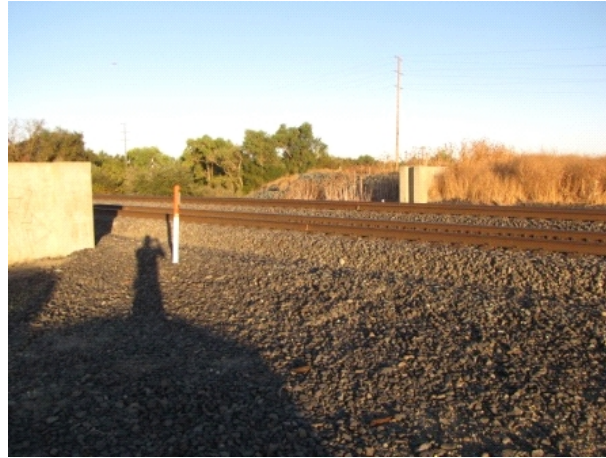
Levee Mile Report Line	1
Start Levee Mile	0.00
End Levee Mile	0.00
Location	Crown
Category	Earthen Levee
Item	Closure Structures

View of the tracks through the closure structure.

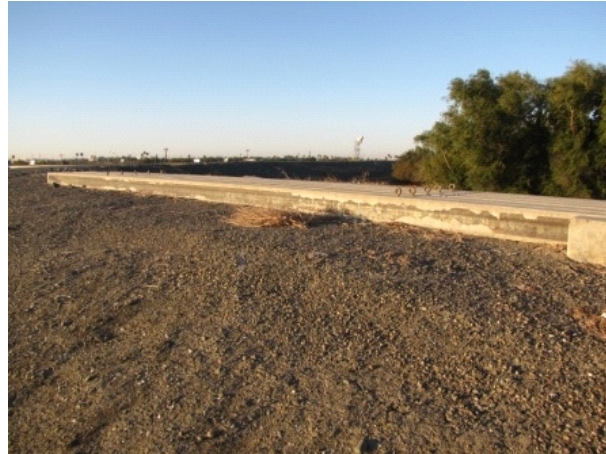
Levee Mile Report Line	1
Start Levee Mile	0.00
End Levee Mile	0.00
Location	Crown
Category	Earthen Levee
Item	Closure Structures

View of stop logs adjacent to the structure.

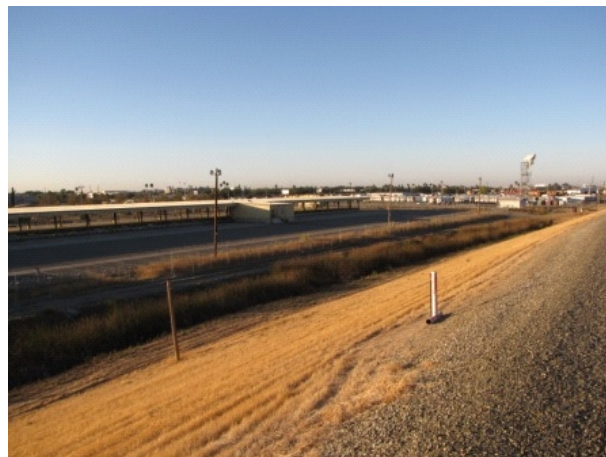
Levee Mile Report Line	2
Start Levee Mile	0.08
End Levee Mile	0.08
Location	Land Side
Category	Earthen Levee
Item	Vegetation

View of the landward slope looking downstream.

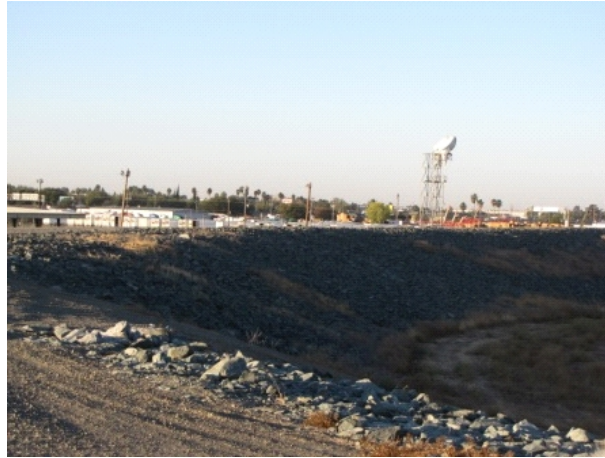
Levee Mile Report Line	3
Start Levee Mile	0.08
End Levee Mile	0.08
Location	Water Side
Category	Earthen Levee
Item	Vegetation

View of the waterward slope looking downstream.

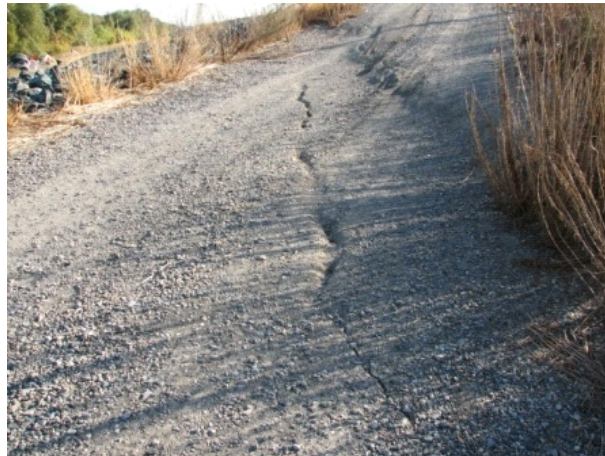
Levee Mile Report Line	5
Start Levee Mile	0.95
End Levee Mile	0.95
Location	Water Side
Category	Earthen Levee
Item	Cracking

Crack located on ramp on waterside of levee at LM 0.95.

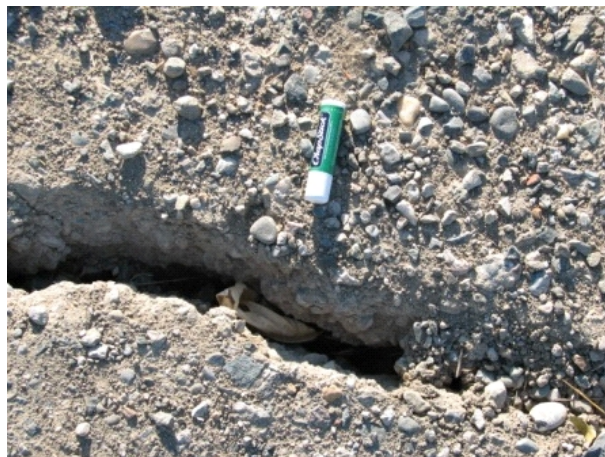
Levee Mile Report Line	5
Start Levee Mile	0.95
End Levee Mile	0.95
Location	Water Side
Category	Earthen Levee
Item	Cracking

Closer view of crack at LM 0.95.

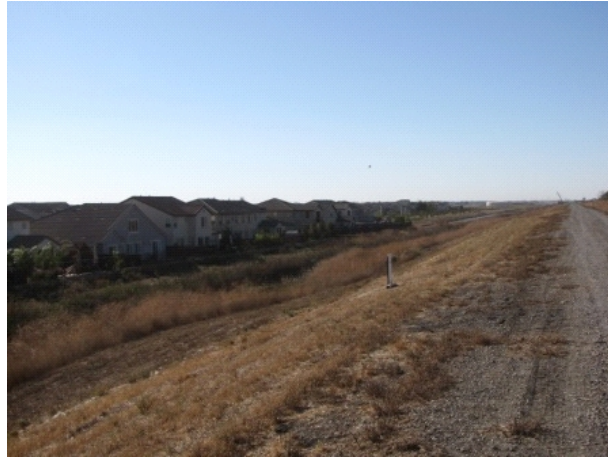
Levee Mile Report Line	12
Start Levee Mile	3.97
End Levee Mile	4.49
Location	Land Side
Category	Earthen Levee
Item	Vegetation

View of vegetation along the toe adjacent to the ditch looking downstream.

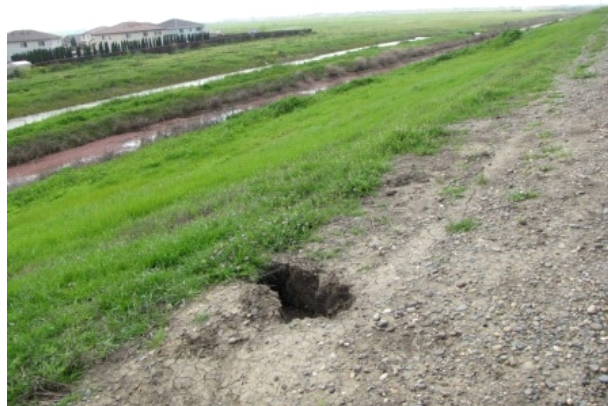
Levee Mile Report Line	13
Start Levee Mile	4.37
End Levee Mile	4.37
Location	Crown
Category	Earthen Levee
Item	Slope Stability

View of an approximate 14" depression at the landward shoulder looking downstream.

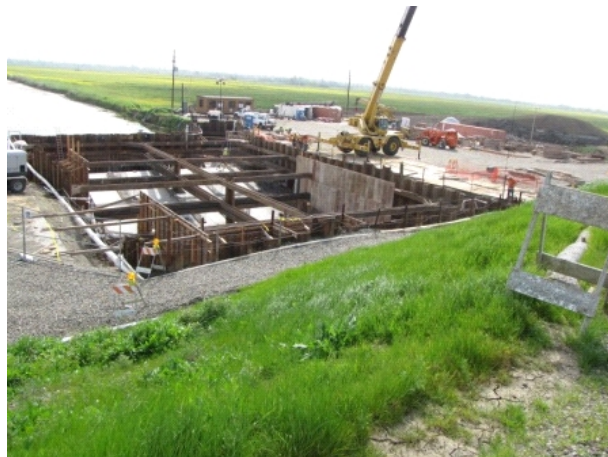
Levee Mile Report Line	18
Start Levee Mile	4.96
End Levee Mile	4.96
Location	Land Side
Category	Earthen Levee
Item	Encroachments

View of the open pit and construction activity on a new pump station on the landward side of the levee.

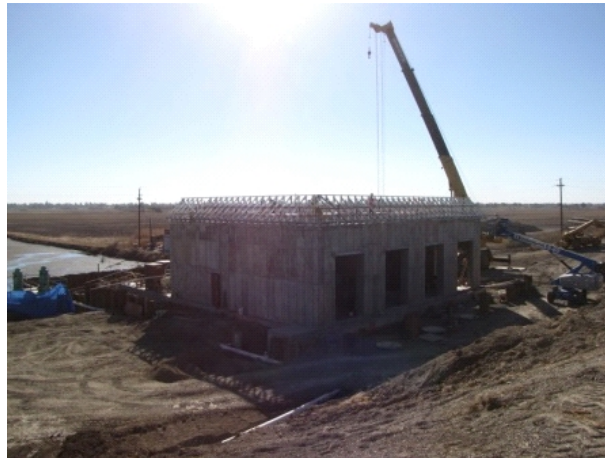
Levee Mile Report Line	18
Start Levee Mile	4.96
End Levee Mile	4.96
Location	Land Side
Category	Earthen Levee
Item	Encroachments

View of construction as of fall 2010.
